STUDIES OF THE USE OF PERVIOUS FENCE FOR STREAMBANK REVETMENT

John T. O'Brien
Hydraulic Engineer

Report No. A-70.1
Prepared under Contract ASC(OR-O)3304
by
Hydrodynamics Laboratories
California Institute of Technology
Pasadena, California

SCS-TP-103

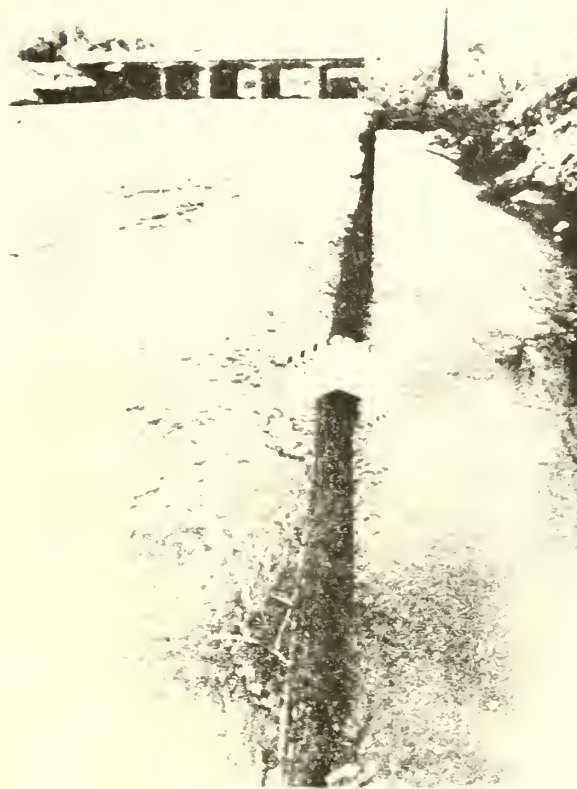
Frontispiece - FLOW ALONG CHANNELS AND BANK SIDES OF FENCE

Looking downstream along rail and wire fence. Note standing waves off debris on fence and sediment deposits upstream from groin in right background. Flow depth in channel is about 1 ft and total flow about 200 cfs.

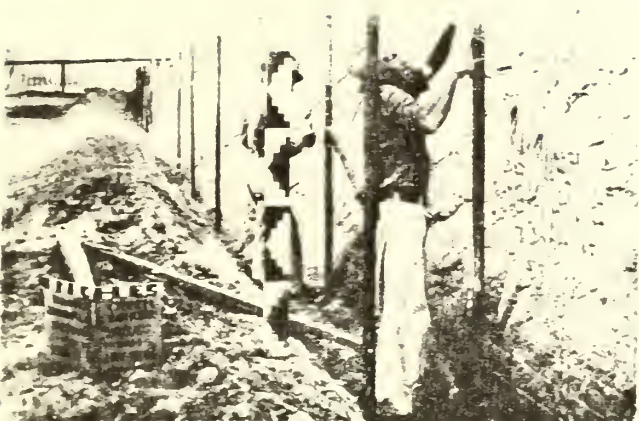
Fig. 1 - PIPE AND WIRE REVETMENT UNDER CONSTRUCTION

Pipe is $2\frac{1}{4}$ in. diameter boiler tubes and fencing is 6 ft wide welded wire with 2-in. by 4 in. openings. (a) Looking upstream at inside of double fence. Note brace. Workmen are tying fencing to pipes. (b) Fencing being stretched. Braces will be left in place. (c) Completed fence. Trench will be backfilled. (d) Pipes (boiler tubes) being driven with portable pile driver. Hammer weighs about 500 lbs.

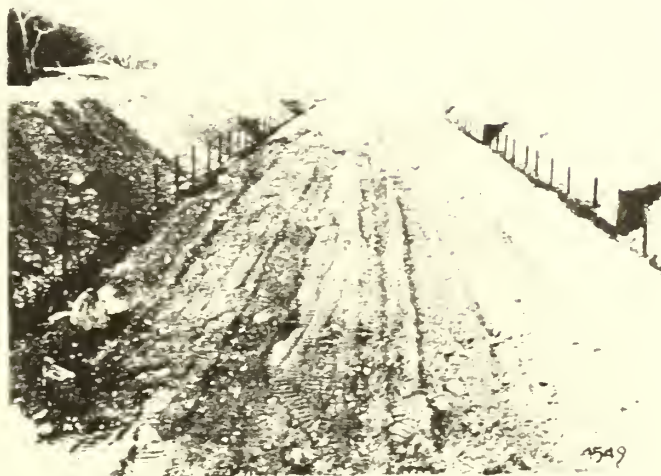
Fig. 3 - DETAILS OF GROIN

Used with rail and wire fence. Angle is 45° with flow. Groins point downstream. (a) Framework. Elwood wire used on groin. Top of welded wire on fence is about at channel bottom. Note timbers bolted to rails. (b) Brush placed between fencing. Note depth to which it is carried. (c) Looking upstream at partially completed channel. Width is about 50 ft and groins are spaced 50 ft. Note cables slung between rails. These are intended to help hold fence together should parts be undercut.

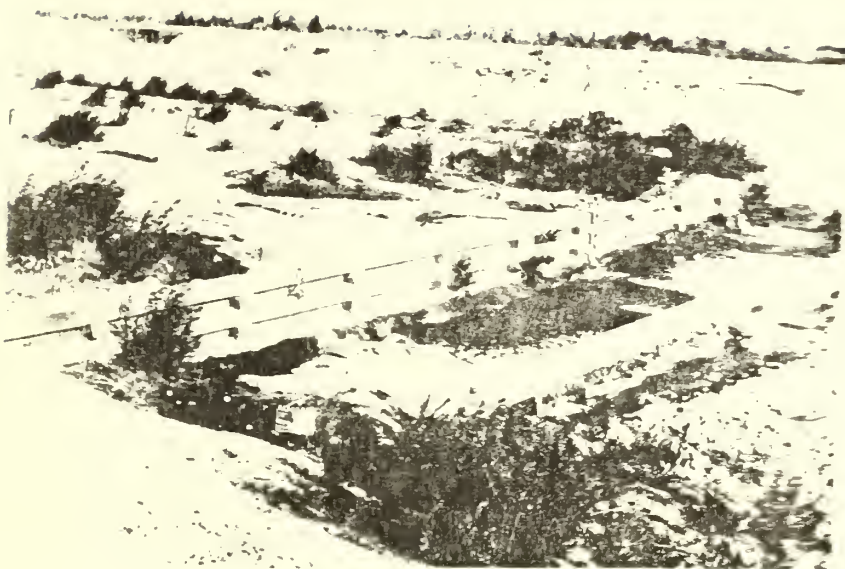
Fig. 5 - ROCK CRIB AND PIPE AND RAIL GRADE STABILIZERS

(a) Looking upstream at a rock crib stabilizer. Note stilling basin with transverse sill. (b) Looking upstream at rail and pipe stabilizer. Improvised stilling basin of mortared rock is buried under sand.

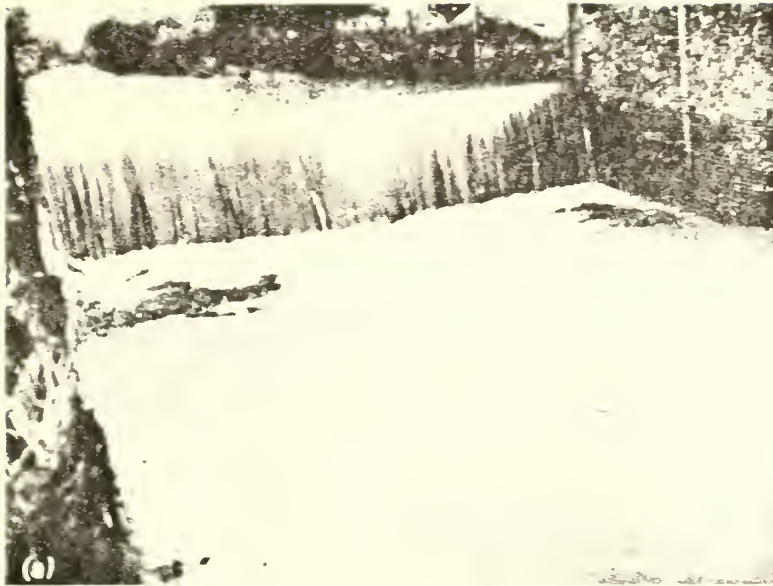
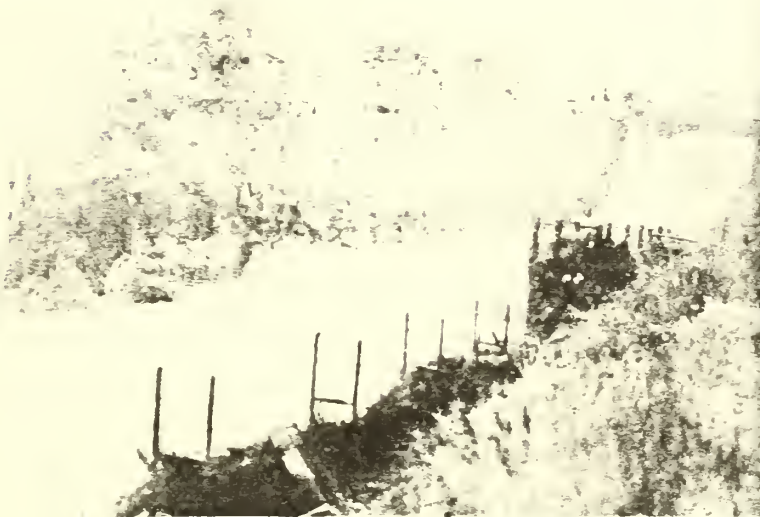
Fig. 7 - FLOW OVER GRADE STABILIZERS

(a) Sheet steel stabilizer. Discharge is about 100 cfs. Width 30 ft and depth at crest about 2 ft. A brush mat is used to form a stilling basin. (b) Pipe and rail stabilizer. Discharge is about 150 cfs. Width 35 ft and depth at crest about 1 1/2 ft. Note partially brushed double fences.

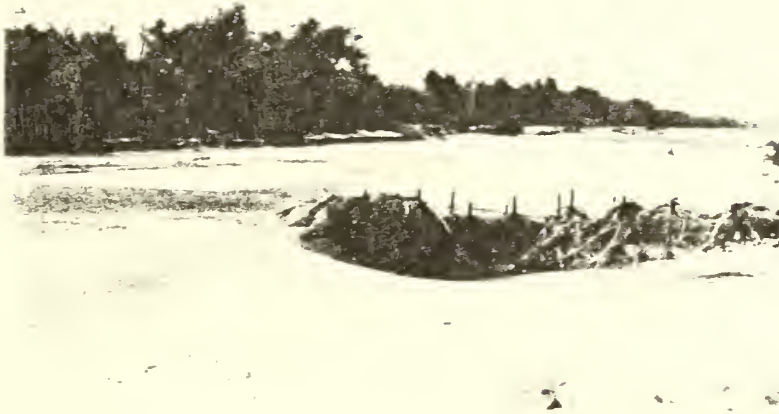
Fig. 8 - GROIN WHICH FAILED

Looking upstream, the flow over and around the groin was sufficient to undermine its supports and cause it to topple downstream.

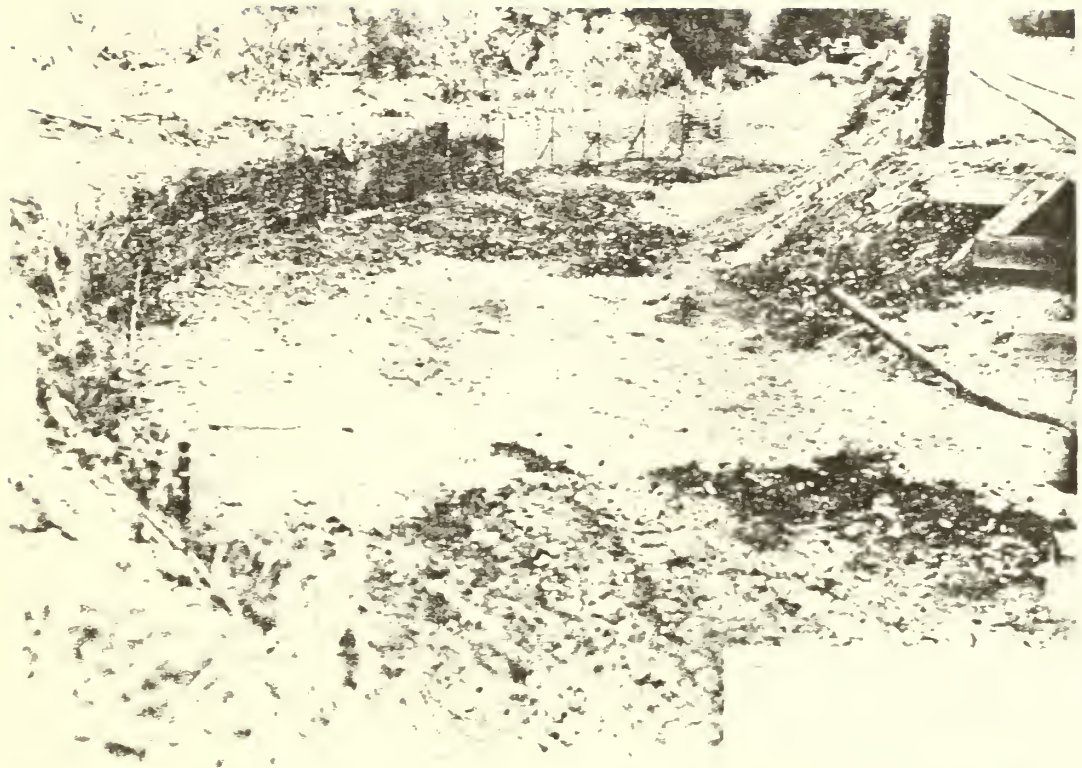
Fig. 10 - PIPE AND WIRE FENCE BEFORE AND AFTER FLOOD

Looking downstream at fully brushed and braced double pipe and wire fence. (a) Before flood. Fence is about 6 ft high. (b) After flood which overtopped fence by 2 ft. Damage was very slight.

the fence is made stable against particularly the dynamic forces of the flowing water. The effect of considerable flow on such a well-designed fence is presented in Fig. 10. Here the fence, located on the outside of a curve as a training wall, was brushed nearly to its full height of about 6 ft. but was so constructed that it was able to turn the flow which overtopped it by about 2 ft. with but very small damage to the fence and the bank behind it. Note in Fig. 10 how the debris from the flood has attached itself to the fence, particularly that portion of the background.

Debris, when closely packed in the fence as shown in Fig. 10, gives the fence an appearance of semi-imperviousness as in some of the fences inspected in Orange (California) County. Here, as shown in Fig. 6-d, the pipes are driven at a 1 on 1/2 slope toward the banks. The fencing is fastened on the bank side of the pipes and backed by closely-packed native reeds. The soil is backfilled against the reeds to form with its opposite a bank-lined trapezoidal cross section. As observed and reported by Bradley (6), such a fence was able to withstand a large flood without serious damage. However, fences of this type were not the particular concern of this investigation.

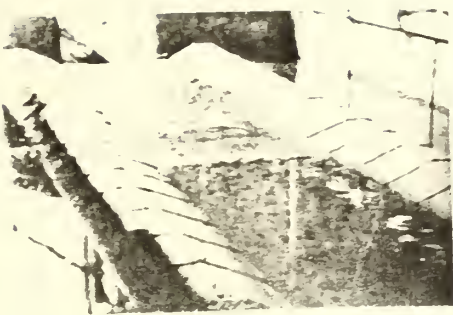
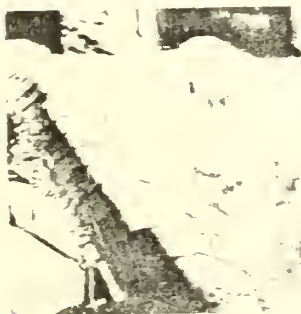
Fig. 13 - PICTORIAL HISTORY OF GROWTH AND BREAKUP OF SAND WAVES IN UNREVETED AND FENCE-REVETED TEST CHANNEL

The action in the unrevetted channel and that with two $\frac{3}{4}$ " mesh fences are shown in parallel vertical columns. (a) Initial flow down channel after start from rest. (b) Surface begins to show undulations due to distortion of bed by sediment movement. (c) Undulations begin to form into wave trains. (d) Waves break upstream.

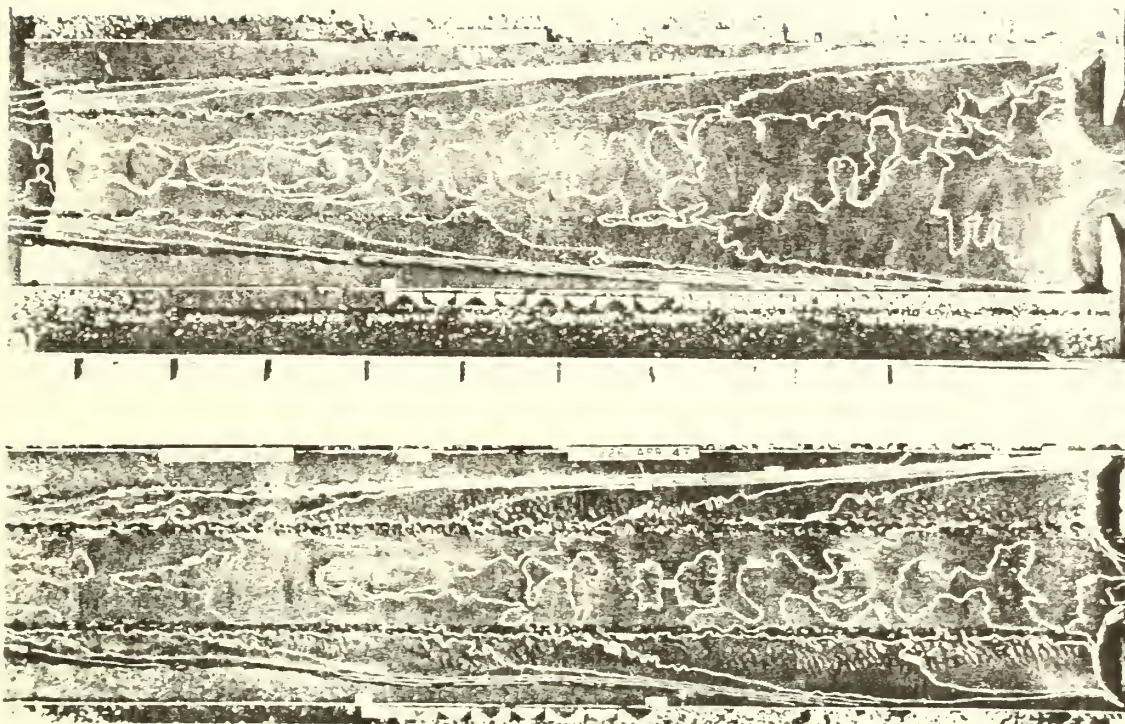
Fig. 20 - COMPARISON OF SCOUR PATTERNS IN CHANNELS REVETED WITH CLOTH TUFTS

See Fig. 12 for details. Tufts covered 100% of wetted bank area at the start of the run. (a) Single cloth tufts. E.R. = 2.3. Note continuously divergent scour pattern. Run #26. (b) Double cloth tufts E.R. = 6.3. Scour pattern indicates that flow was stabilized at about station No. 15. Scour around lower 10 ft may be reaction from wooden terminus. Note tendency to meander. Run #28.
